## SERVICE BULLETIN

EC99-013c

### ECM REPROGRAMMING FOR NISSAN VEHICLES

#### APPLIED VEHICLES:

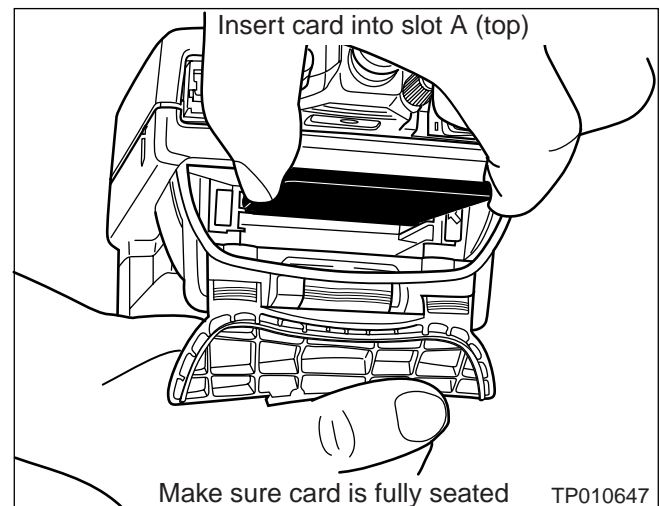
Figure 1

1. Install the Reprogramming Card into CONSULT-II.

- The Reprogramming Software Card is the “orange” Card.
- Use slot A—top slot (see Figure 1).

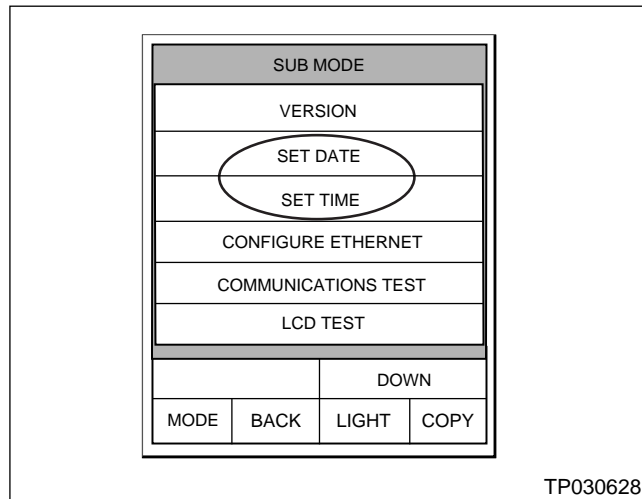
Figure 2

C. Touch **SET DATE** (see Figure 2).

- 1) If the date is not correct, touch the **MONTH**, **DAY** or **YEAR** as needed. Then adjust it by using arrow keys. Once done, press **SAVE**, press **BACK**, and go to step D.
- 2) If the date is OK, press **BACK** and go to step D.

D. Touch **SET TIME** (see Figure 2).

- 1) If time is not correct, touch the **HOUR**, **MINUTE** or **AM/PM** as needed. Then adjust it by using arrow keys. Once done, press **SAVE**, press **BACK** and go to step 5.
- 2) If time is OK, press **BACK** and go to step 5.

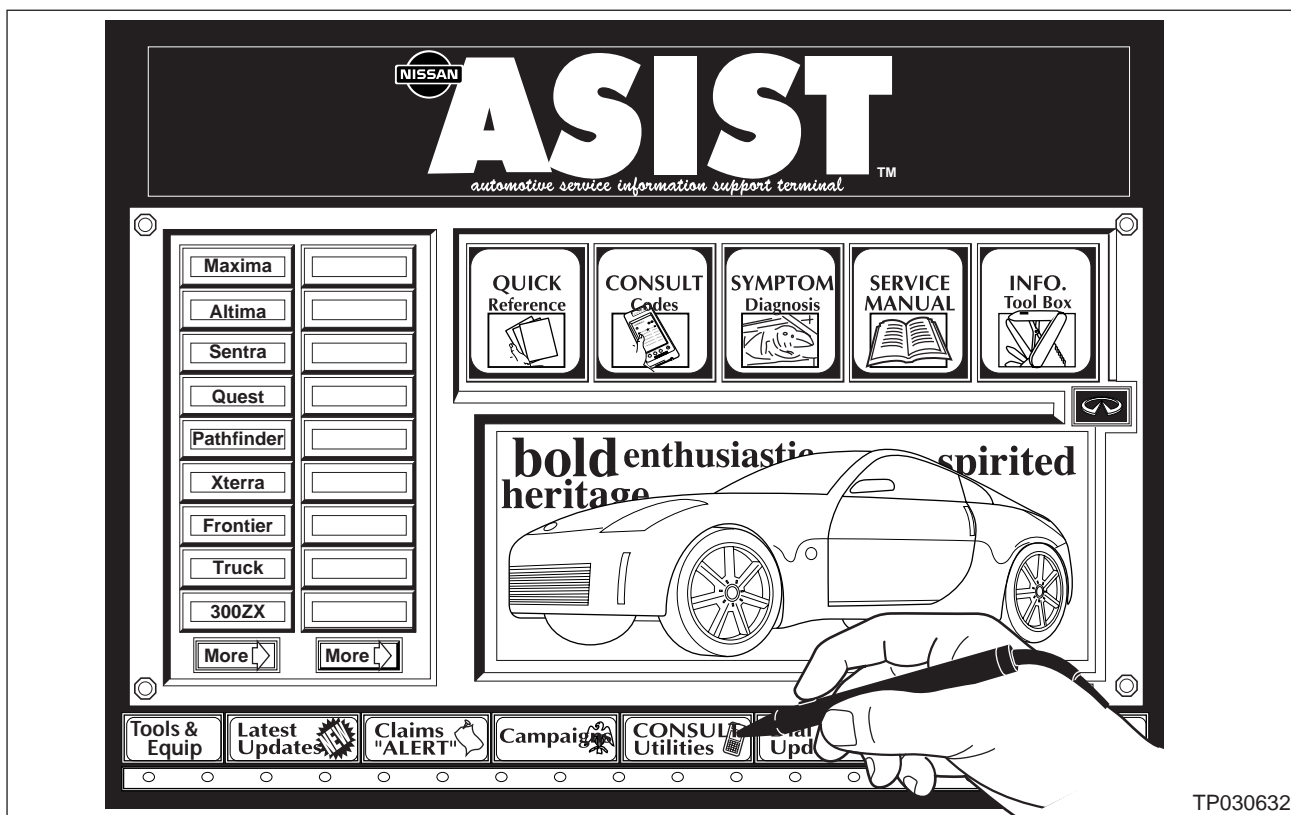
Figure 3

- From the ASIST PC main menu screen, select "**CONSULT UTILITIES**" (see Figure 3).

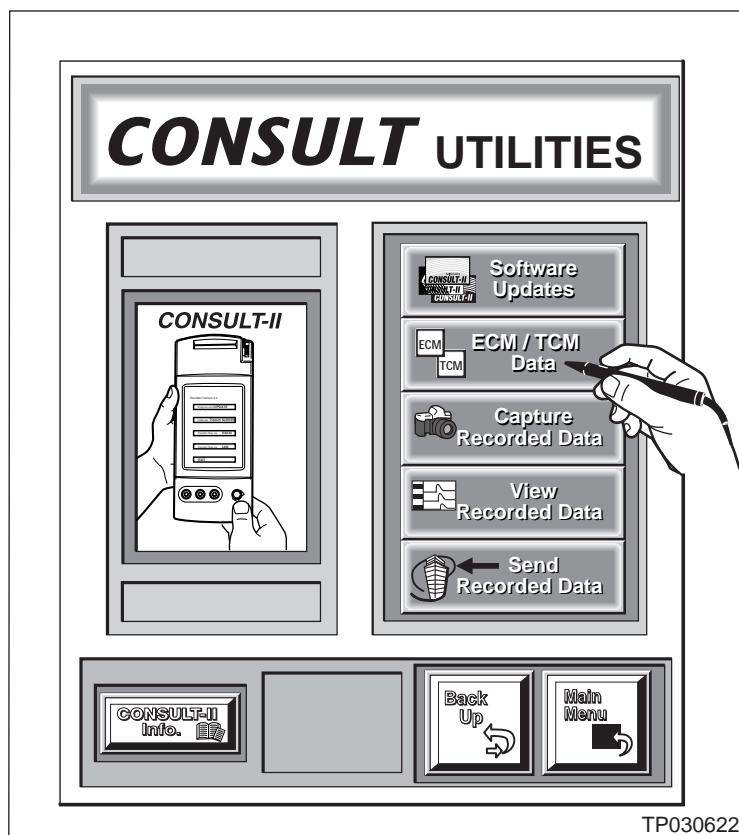
Figure 4

- From the "**CONSULT UTILITIES**" screen, select "**ECM / TCM DATA**" (see Figure 4).

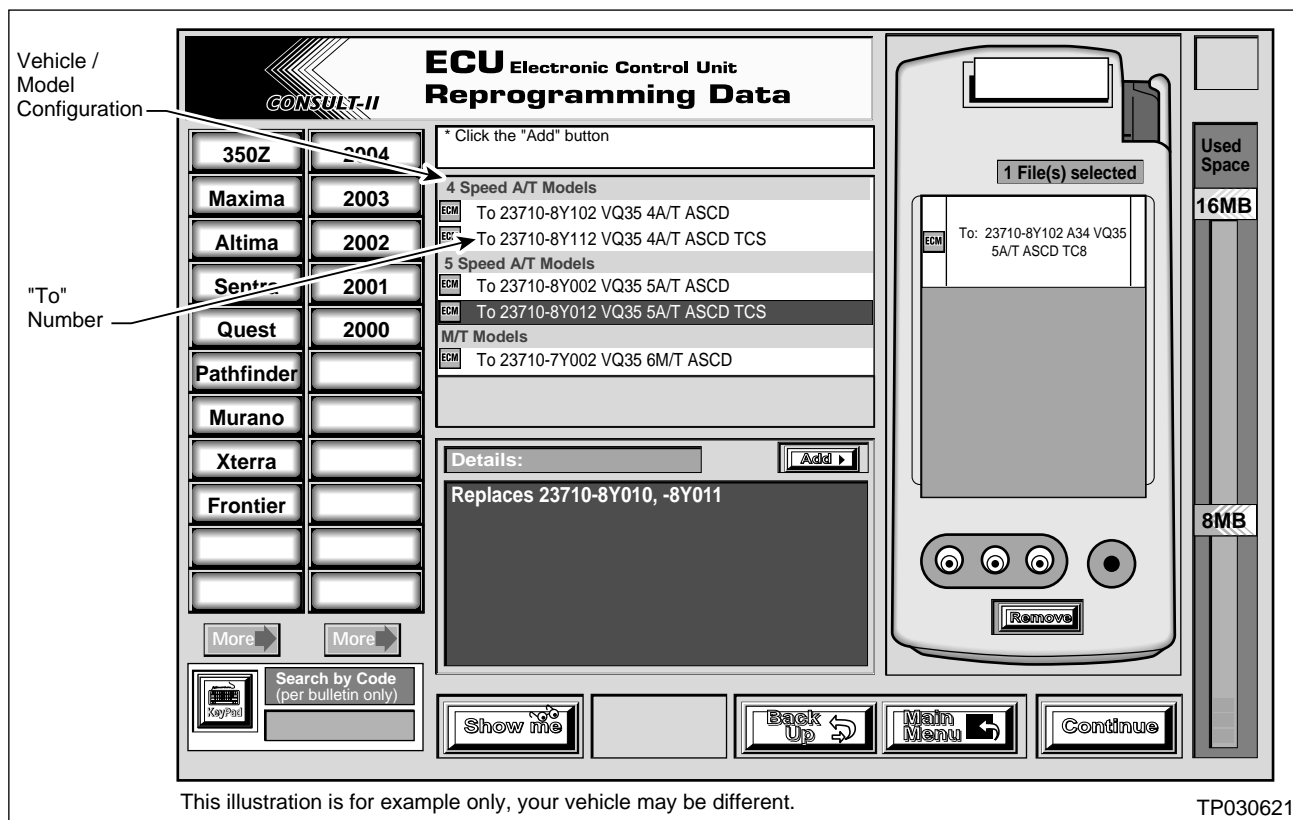
Figure 5

7. Select the "ECU REPROGRAMMING DATA" (see Figure 5) as follows:

A. Select vehicle model and model year.

B. Select the correct reprogramming data:

1) Locate the specific "Model Configuration" (Example: VQ35 4A/T ASCD).

2) Select (click on) the "To" number.

C. Click on the "Add" button to add data to the "File(s) selected" list. This list is on the right side of the screen.

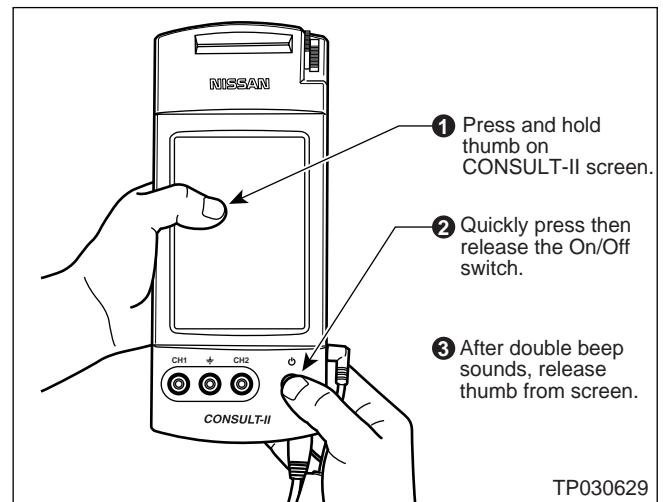
8. Turn "ON" CONSULT-II as shown in Figure 6.

**NOTE:** If you accidentally choose a menu option other than "Transfer Files via LAN"; turn CONSULT-II "OFF", and then back "ON" as shown in Figure 6 above.

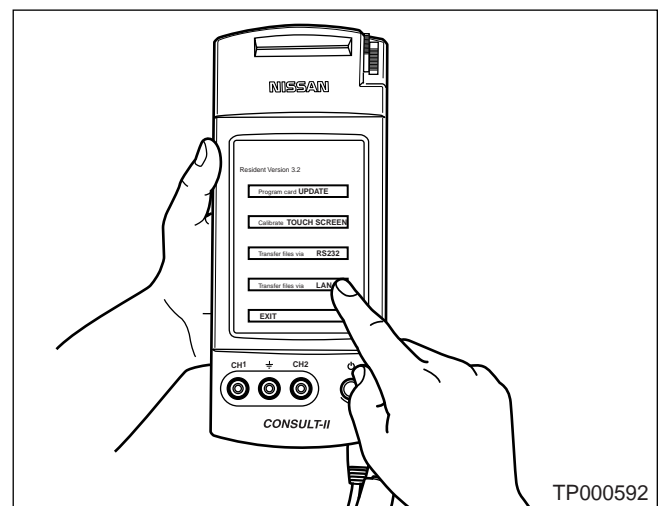
Figure 7

9. Select **Transfer files via LAN** (see Figure 7).

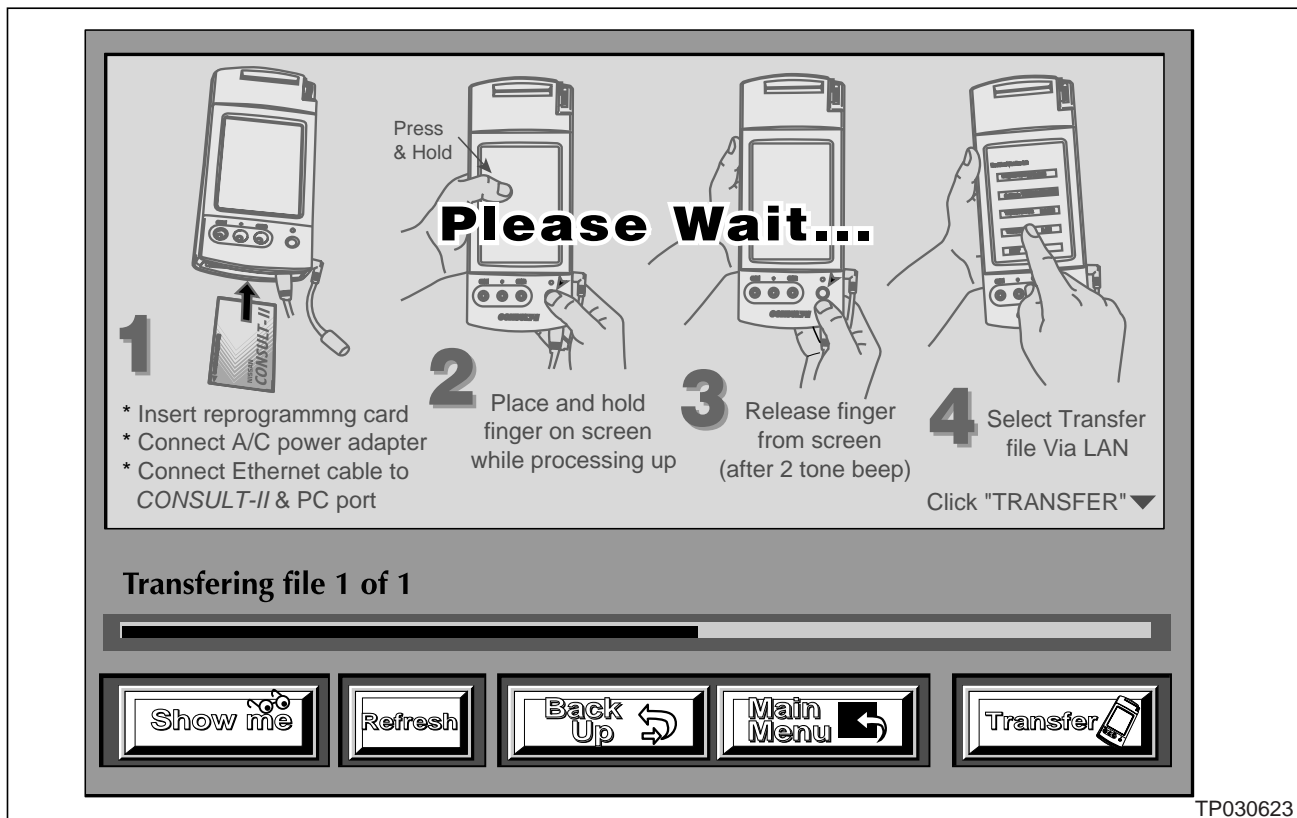
Figure 8

A. On the ASIST screen, click on "**Transfer**" (see Figure 8).

- Data transfer will take about 15 seconds per file.
- Transfer progress is displayed on the ASIST screen (see Figure 8).

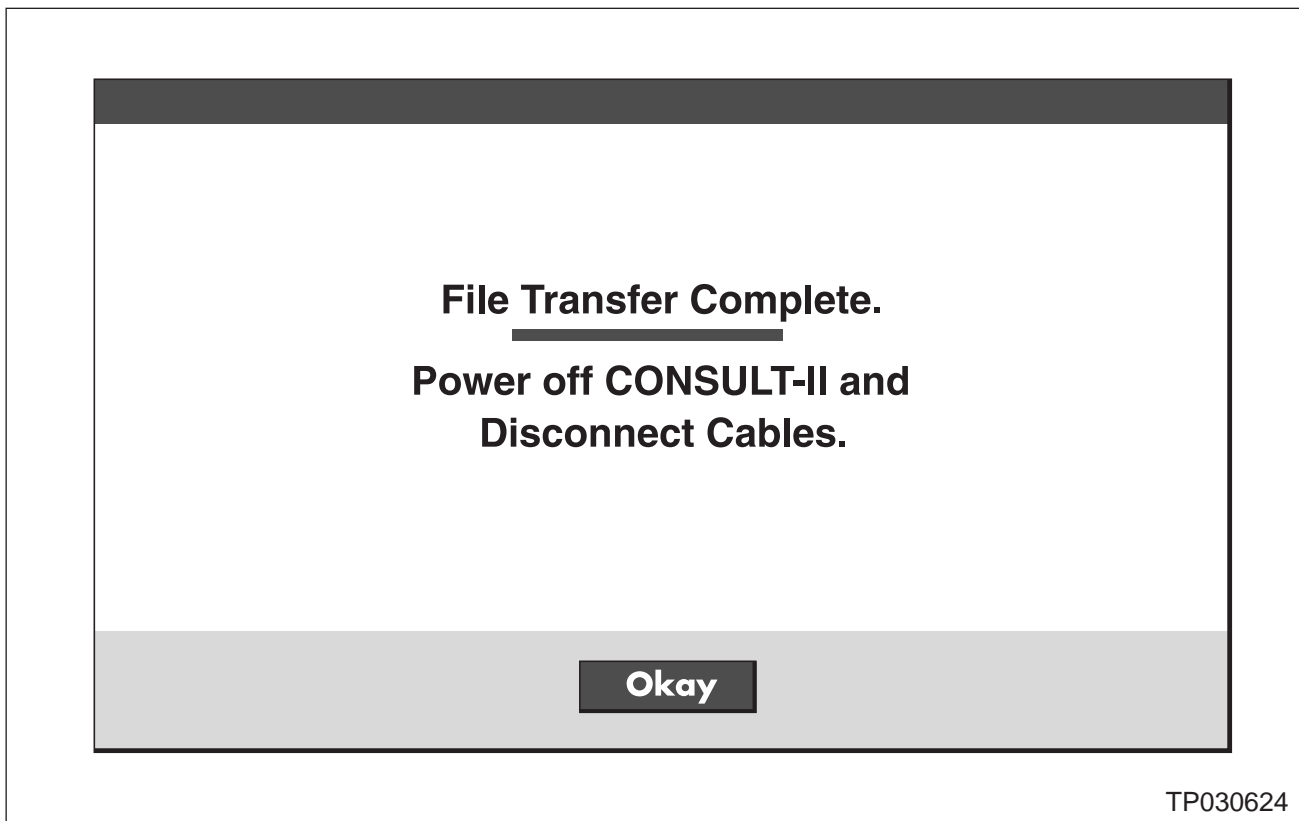
Figure 9

**CAUTION: DO NOT DISCONNECT THE ETHERNET CABLE UNTIL "COMPLETE" IS DISPLAYED AS SHOWN IN FIGURE 9 ON THE NEXT PAGE.**

11. When transfer is complete (see Figure 9):

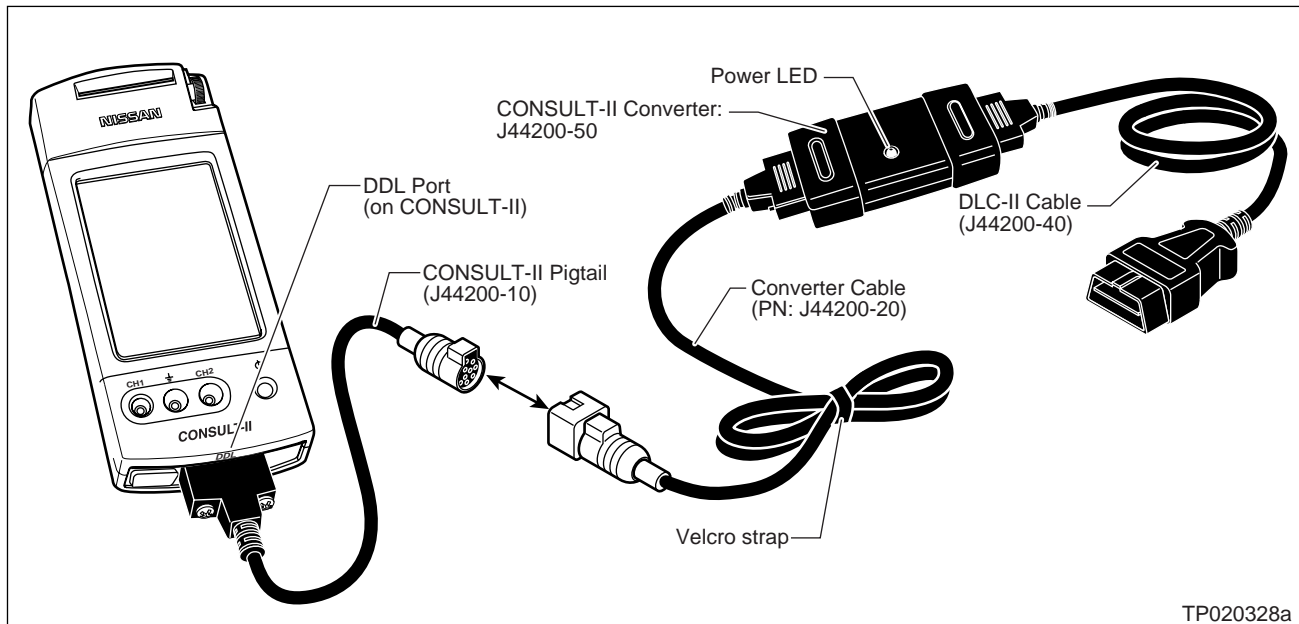
14. Connect CONSULT-II to the vehicle using the DLC-II cable with black Converter Box (see Figure 10 on next page).

- Make sure the DLC-II is straight and fully plugged in to the vehicle.
- Make sure all other DLC-II cable connections shown in Figure 10 are connected properly.

- Nissan requires the use of essential tools shown in Figure 10 when performing ECM reprogramming.
- J44200-10 "Pigtail" should not be removed from the CONSULT-II DDL Port. This "Pigtail" allows use of the stronger "quick disconnect" cable set.
- If cables are very often changed at the DDL Port (base) of the CONSULT-II unit, cable connector pin damage may result.
- If there is connector pin damage, ECM reprogramming may fail. Permanent ECU damage can occur.

- A reading above 12 volts confirms;
  - a. The DLC-II is properly connected to the vehicle,
  - b. The vehicle battery voltage is sufficient for ECM reprogramming, and
  - c. CONSULT-II has a sufficient power supply to perform ECM reprogramming.
- If the vehicle's battery voltage (“Charger Input”) is below 12 volts, one or more of the following may be the cause:
  - a. The battery charger you hooked up in section 1 is not charging the battery (poor connection or it is not working).
  - b. The DLC-II does not have a good connection to the vehicle (not straight).
  - c. The DLC-II cable may have a malfunction (damaged wire or pins).
  - d. The CONSULT-II Converter (J44200-50 / black box) is not working correctly (see Figure 10 on page 10).

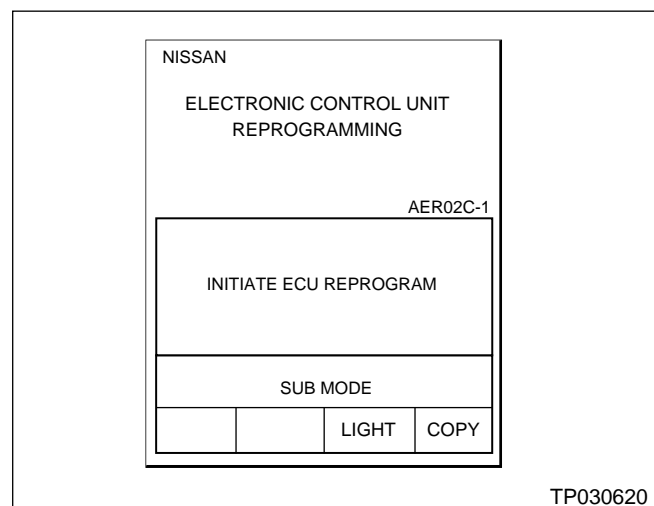
Figure 11

- CONSULT-II will turn "ON" automatically (see Figure 11).
- Confirm that all electrical loads\* (except for the ignition) are "OFF".

17. Press **SUB MODE** (see Figure 11) then:

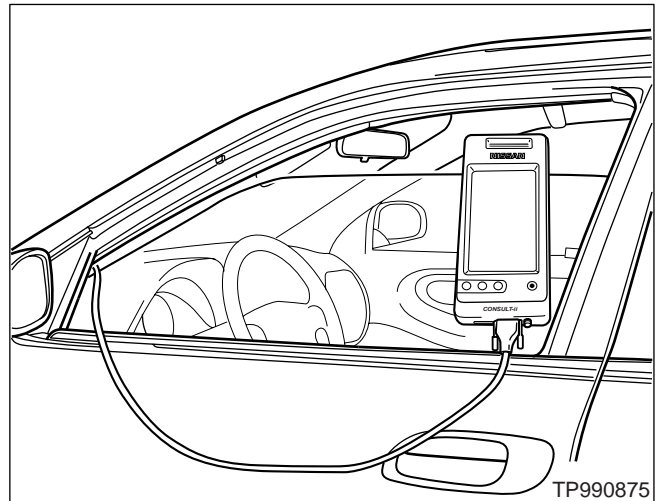
Figure 12

16. Roll down the driver's window part way, exit the vehicle, close the door, and hang the CONSULT II unit on the outside of the window (see Figure 12).

- This step is necessary to ensure the CONSULT-II and DLC-II cable will not be disturbed during reprogramming.

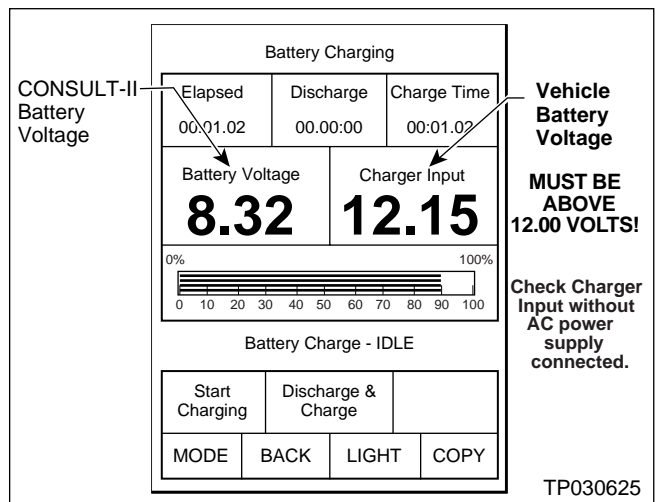
18. Check the CONSULT-II's "Charger Input" reading (see Figure 13).

19. The “Charger Input” reading **MUST** be above 12 volts (see Figure 13 on page 11).

- Do not attempt ECU reprogramming if the vehicle's battery voltage is below 12 volts.
- Permanent ECU damage can occur if the vehicle battery does not maintain the minimum voltage during ECU reprogramming.
- If “Charger Input” is above 12 volts, power from the vehicle battery will keep CONSULT-II's power supply at the correct level during reprogramming. (see Figure 13).

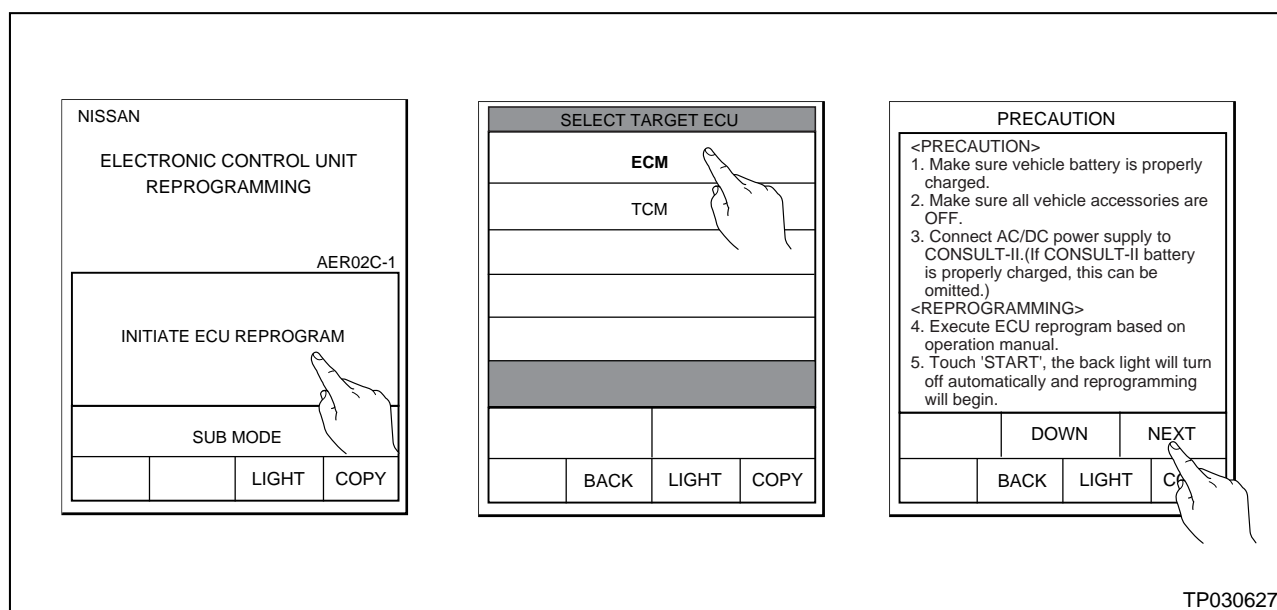
Figure 14

20. Press **INITIATE ECU REPROGRAM** (see Figure 14), then

- A. Press **ECM**
- B. Review the precaution
- C. Press **NEXT**

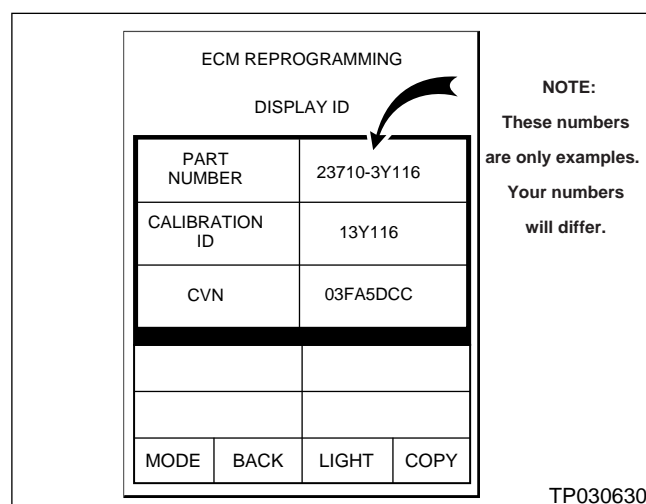
Figure 15

21. Press **CHECK ECM P/N** to “confirm” (take note of) the current ECM part number (see Figure 15).

**NOTE:** This is the vehicle’s ECM part number BEFORE reprogramming.

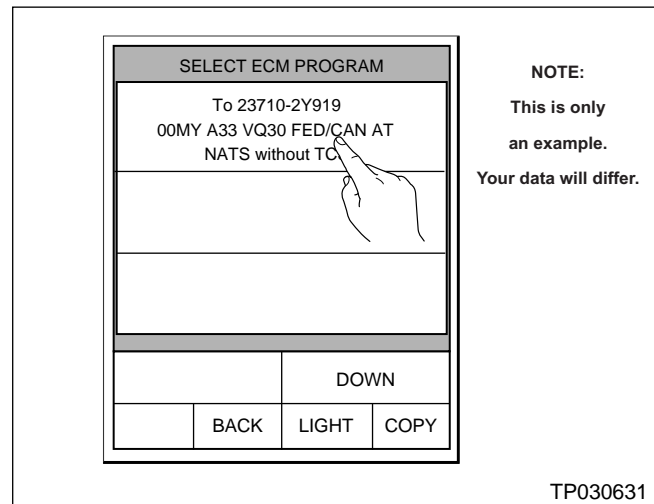
Figure 16

24. Select the ECM program to install (see Figure 16).

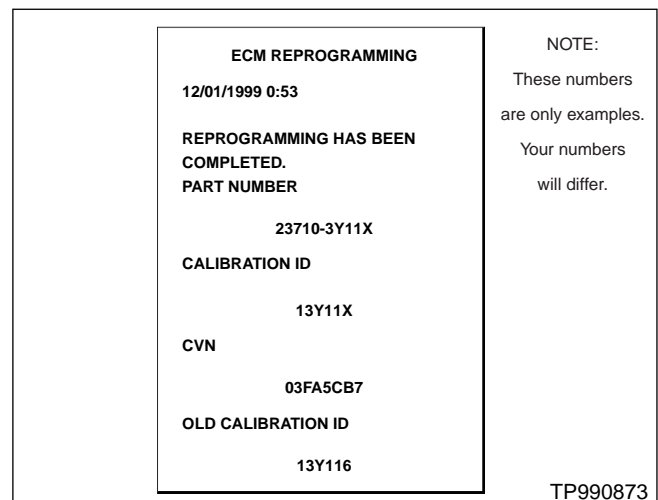
Figure 19

27. When the reprogramming is complete, CONSULT-II will "beep", turn the screen backlight back "ON" and automatically print out a report (see Figure 19).

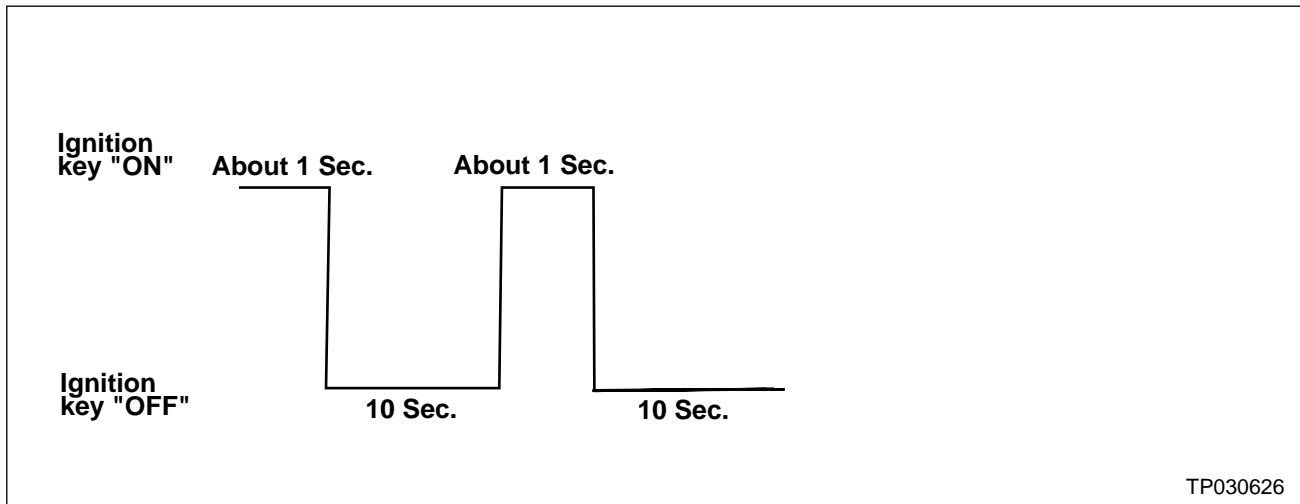
Figure 20

30. **Wait more than 10 seconds, then turn the ignition switch "ON" for 1 second. Then, turn the ignition switch "OFF" again for 10 seconds (see Figure 20).**

- This will reset ECM self learned Data.
